September 17, 2010

Attn: Christopher Regan  
Project Manager  
DC Housing Enterprises  
1133 North Capitol Street, NE, Suite 147  
Washington, DC 20002

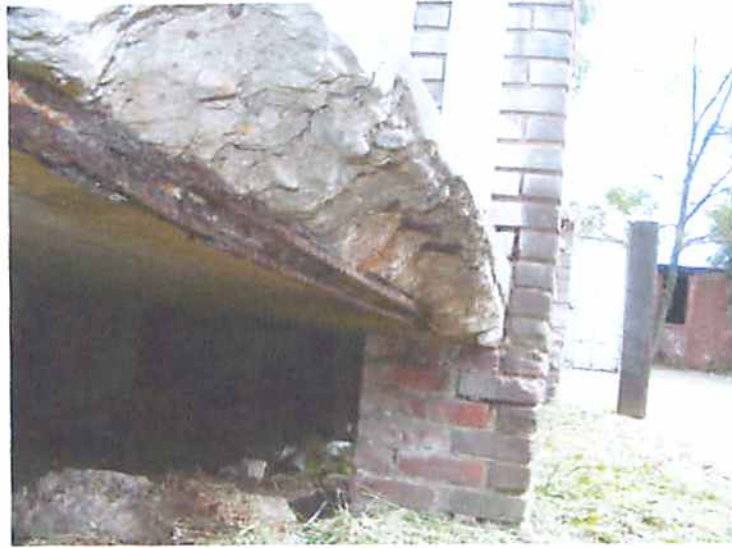
**Photo R3 Structure #2238 - Shows Spalled Exterior Edge of Concrete  
Porch with Corroded Reinforcing Steel**

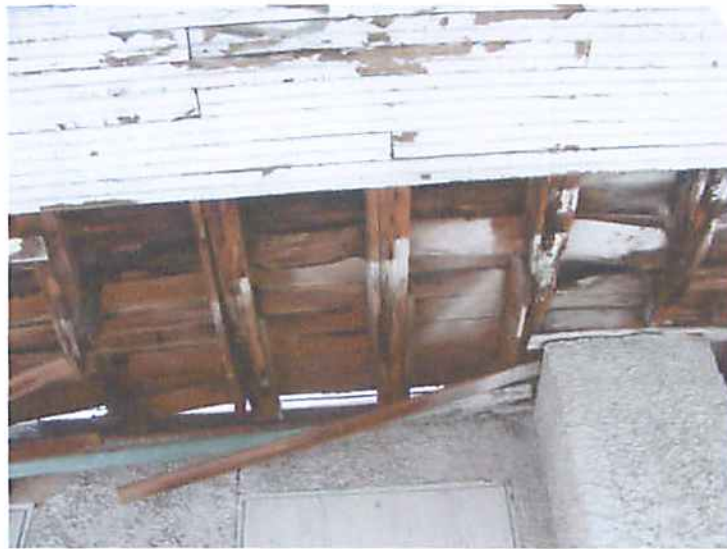
**Photo R4 Structure #2238 - Shows Damage Porch Roof Framing**

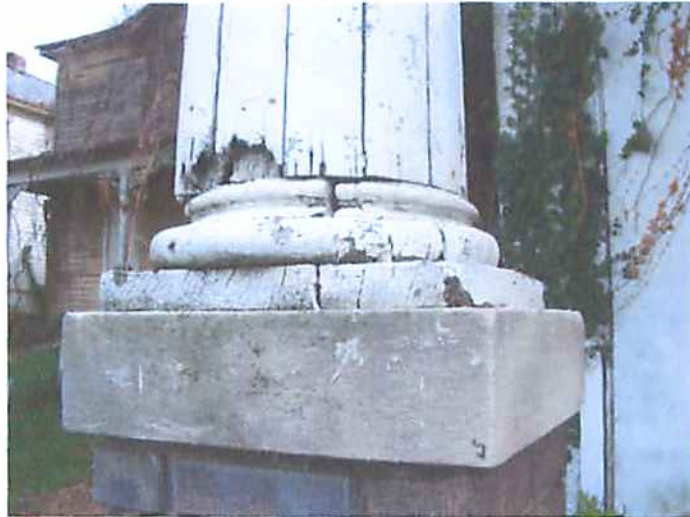
**Photo R5 Structure #2238 - Base of Wood Porch Post Deteriorated- In Addition There is No Connection of the Column to the Pier**

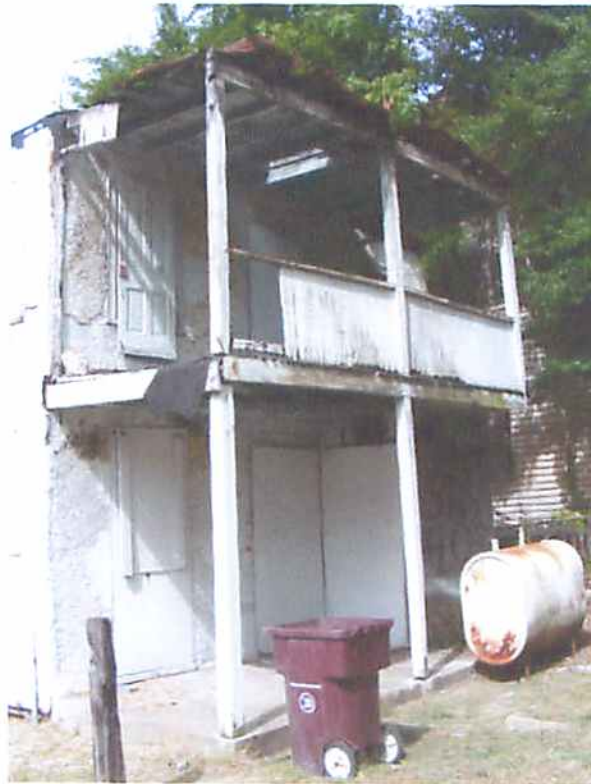
**Photo R6 Structure #2238 - Rear Covered Porch - Corner Post Missing**

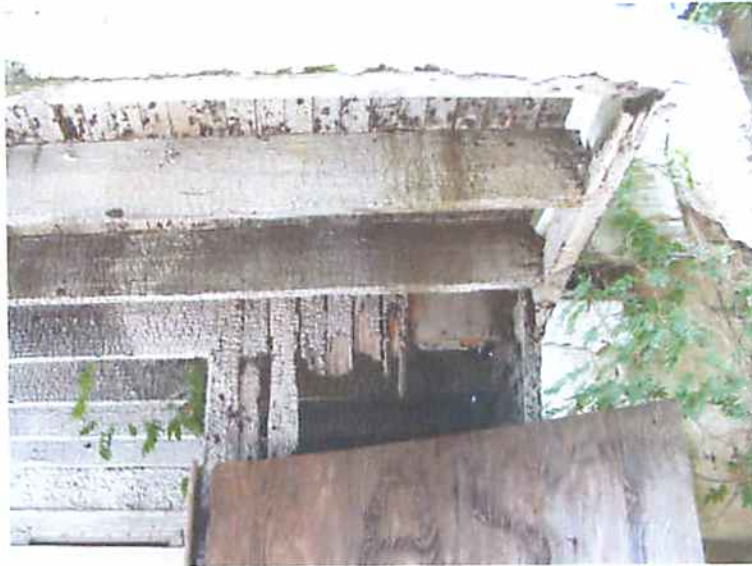
**Photo R7 Structure #2238 - Second Floor Framing of Exterior Deck.  
Deteriorated with Fire Damage.**

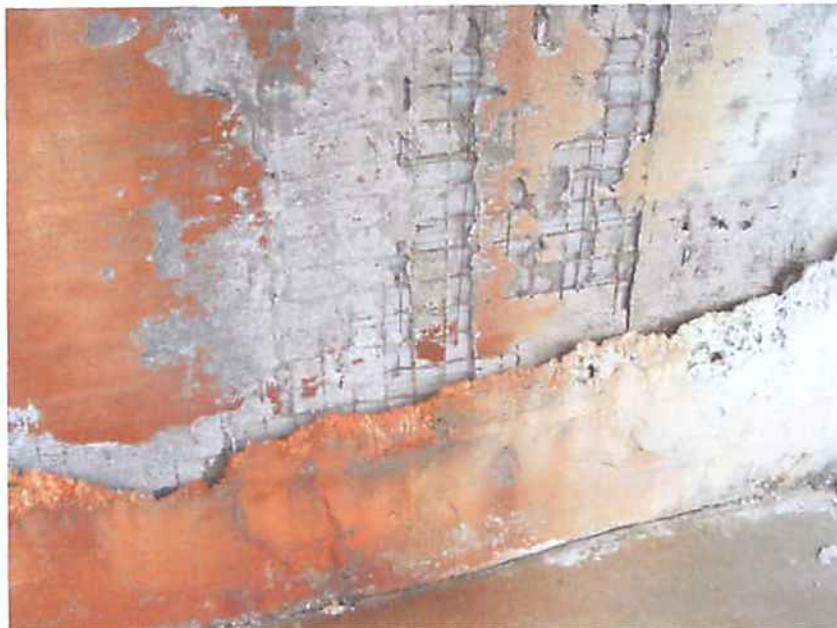
**Photo R8 Structure #2238 - Typical Wall Covering - Wire Fabric Nailed  
to Wood Shingles Then Covered with Two Thin Layers of Cement.**

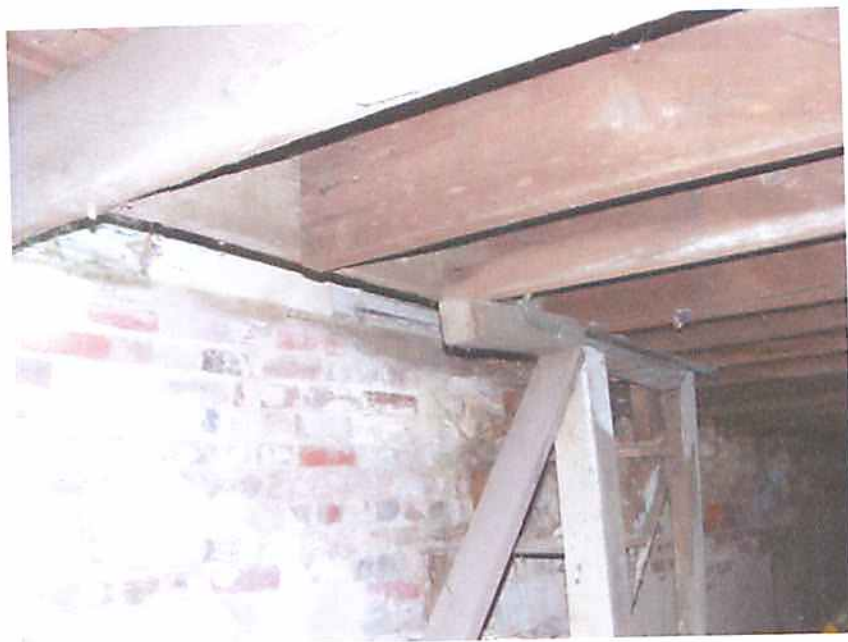
**Photo R9 Structure #2238 - First Floor Framing Around Stair Opening - Deflected and Failing.**

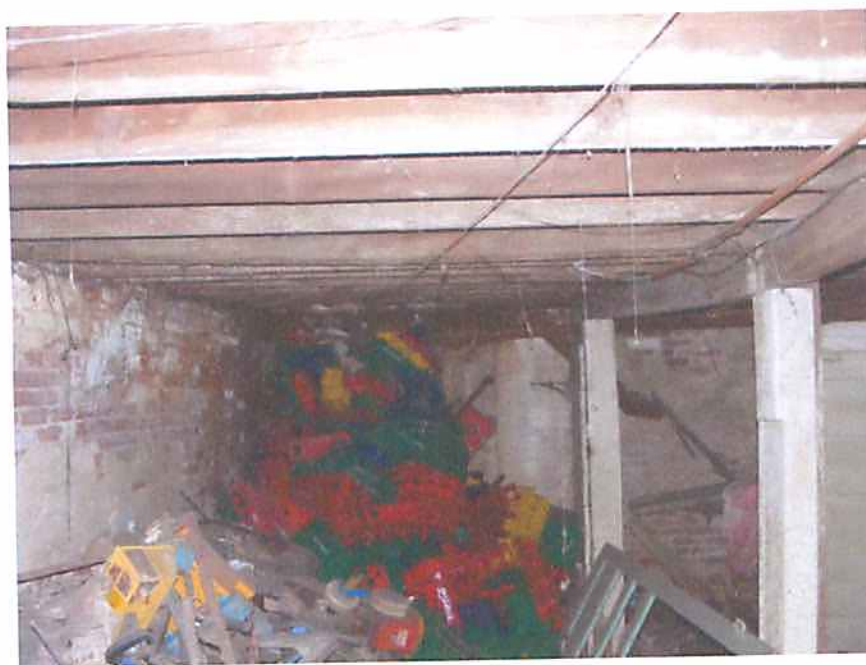
**Photo R10 Structure #2238 - Post, Beam, Joist First Floor Framing**

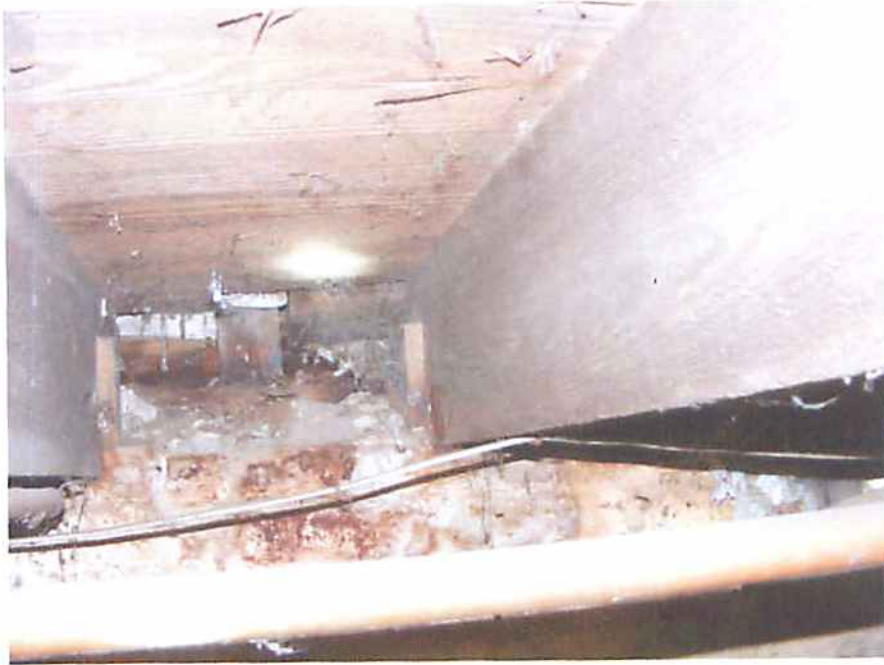
**Photo R11 Structure #2238 - End Bearing of Existing First Floor Joists.**  
**Shows Deteriorated Wall Studs, Wood Plate and Joists**

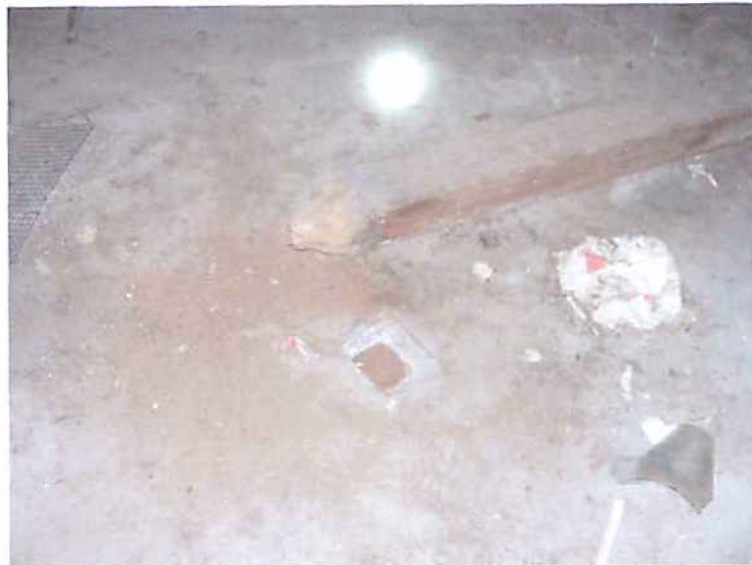
**Photo R12 Structure #2238 - Collapsed Post Between Basement and First**  
**Floor Framing - Base of Post Deteriorated - Typical Condition For All**  
**Basement Wood Posts**

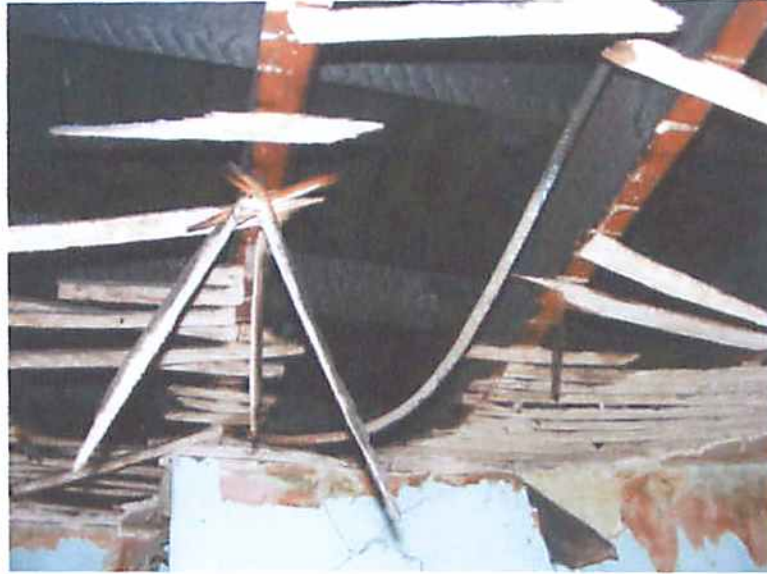
**Photo R13 Structure #2238 - Fire Damage At Roof Level at Rear of Building**

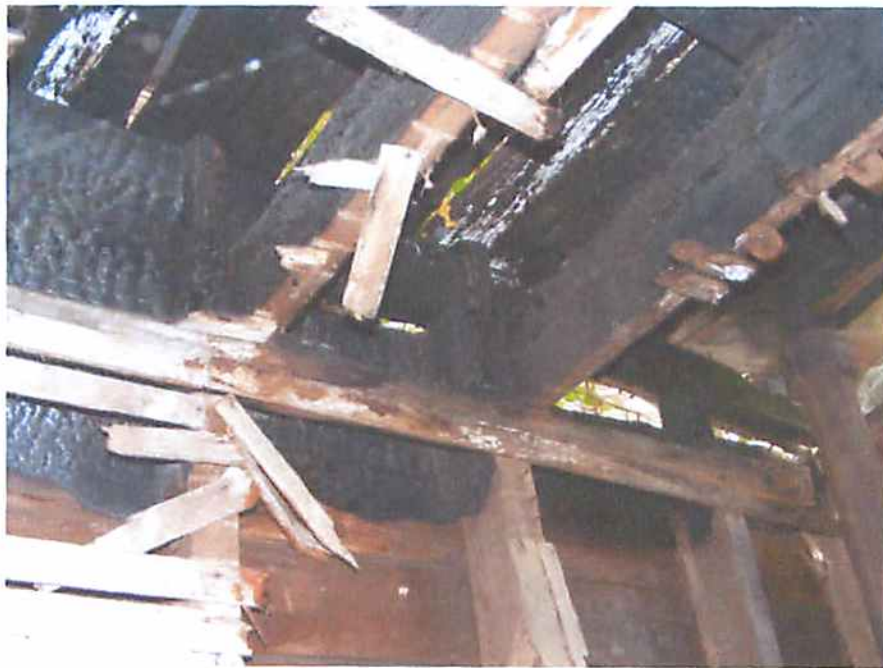
**Photo R14 Structure #2238 - Fire Damage At Roof Level at Rear of Building**

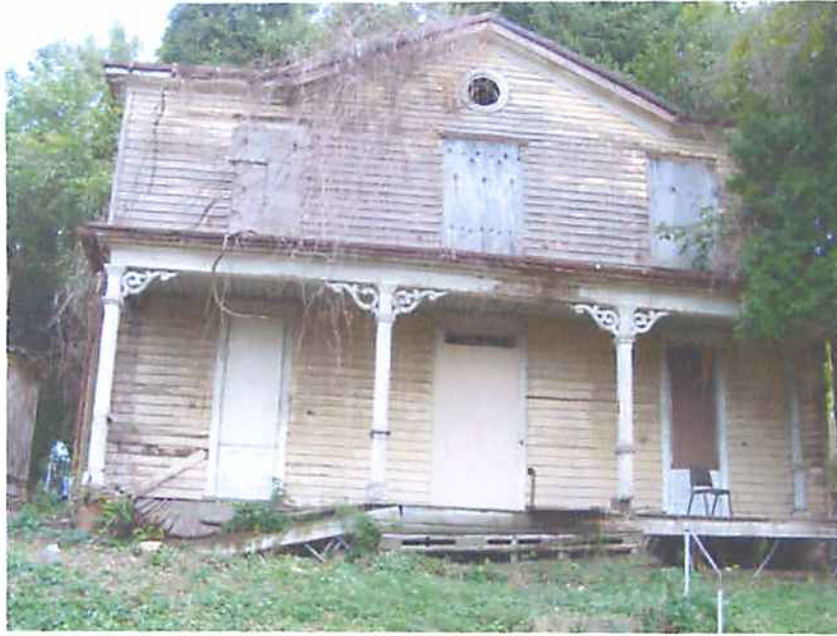
**Photo M1 Structure #2234 - Front of Building #2234**

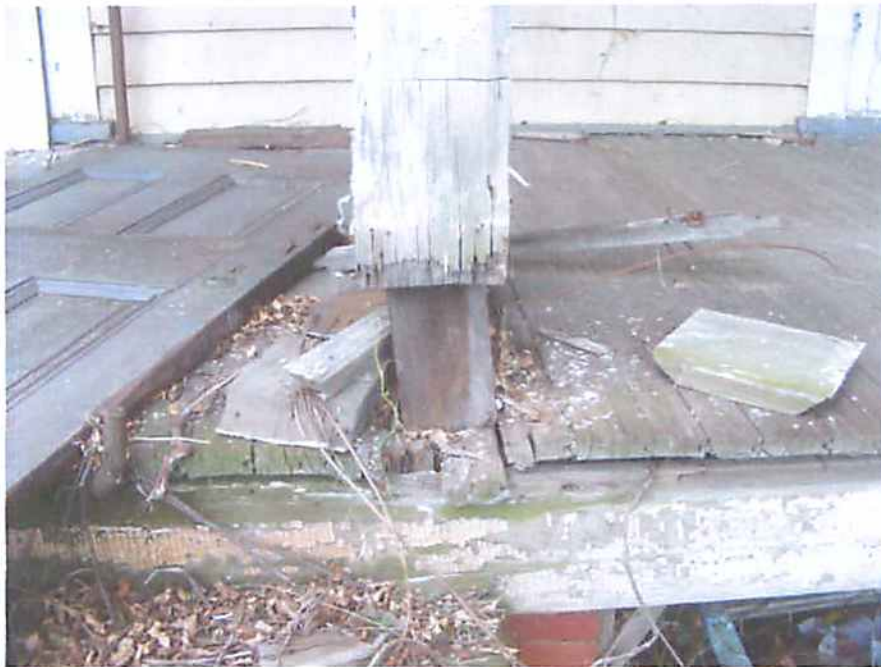
**Photo M4 Structure #2234 - Failed Porch Post**

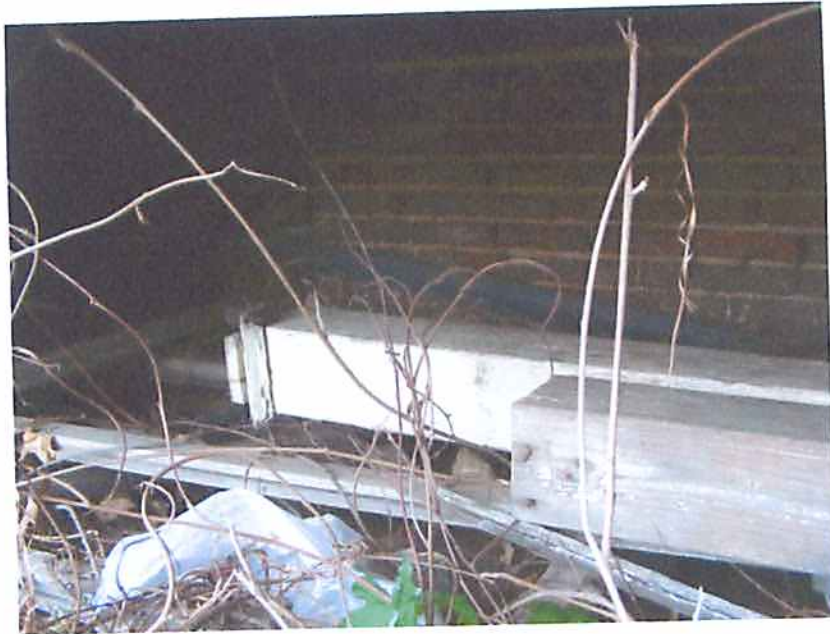
**Photo M5 Structure #2234 - Deteriorate Exterior Face of Existing Brick Wall Below Porch**

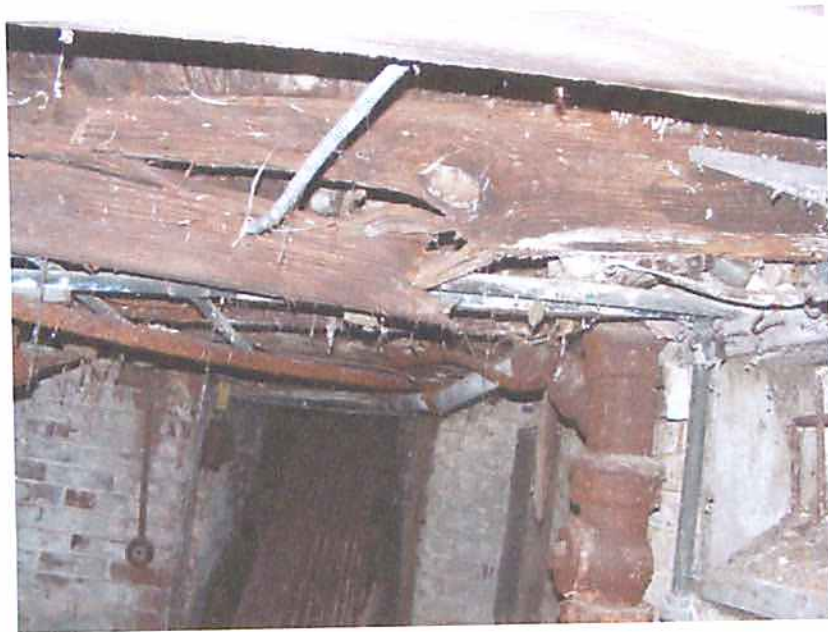
**Photo M6 Structure #2234 - Collapsed First Floor Framing**

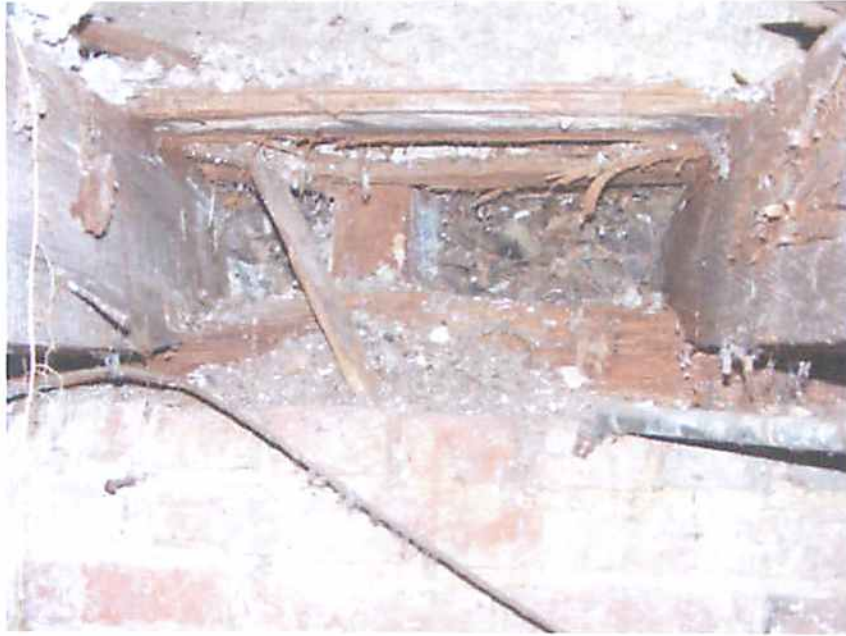
**Photo M9 Structure #2234 - Damaged Wood Plate, Studs, Planking and Joists at Exteior Brick Bearing Wall**

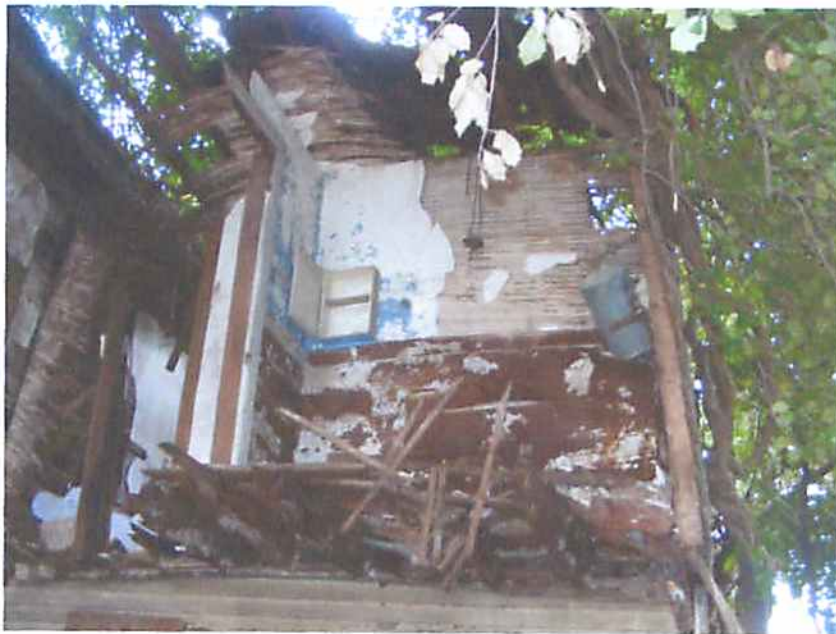
**Photo M10 Structure #2234 - Collapsed Second Floor and Roof Framing at Rear of Building**

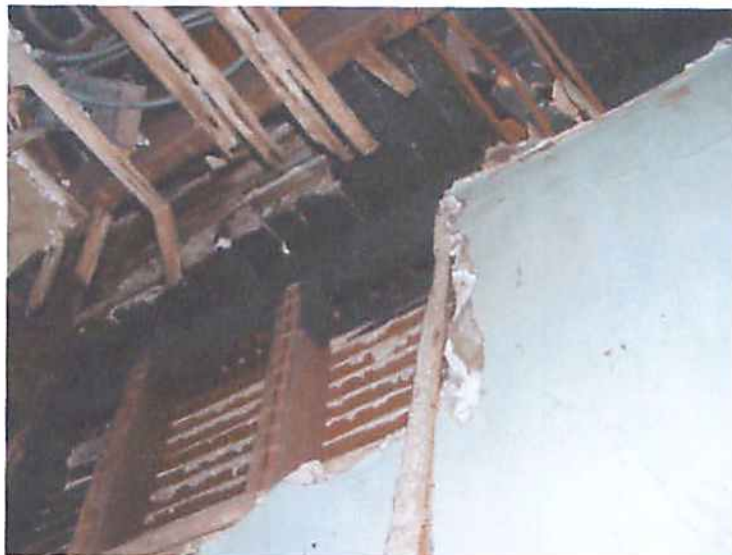
**Photo M12 Structure #2234 - Interior Fire Damage to Ceiling and Roof Framing at Rear of Building**

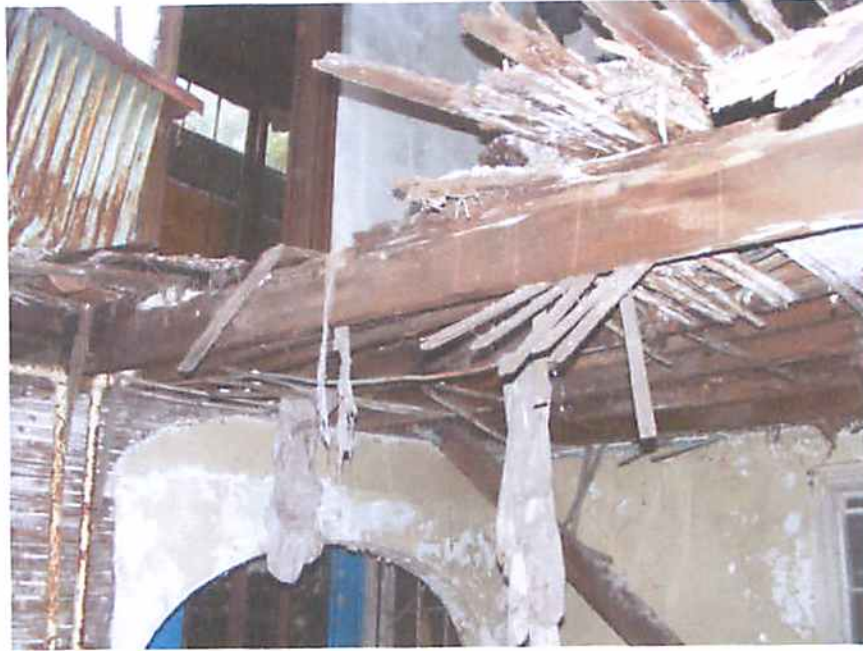
**Photo M13 Structure #2234 - Collapsed Second Floor Framing**

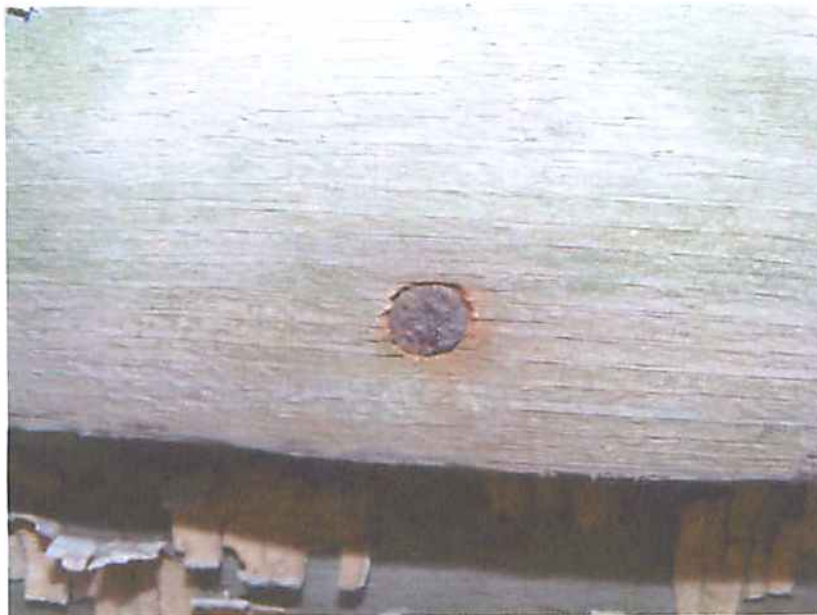
**Photo M14 Structure #2234 - Rusted Nail Connection Wood Shingles to Exterior Stud Walls**

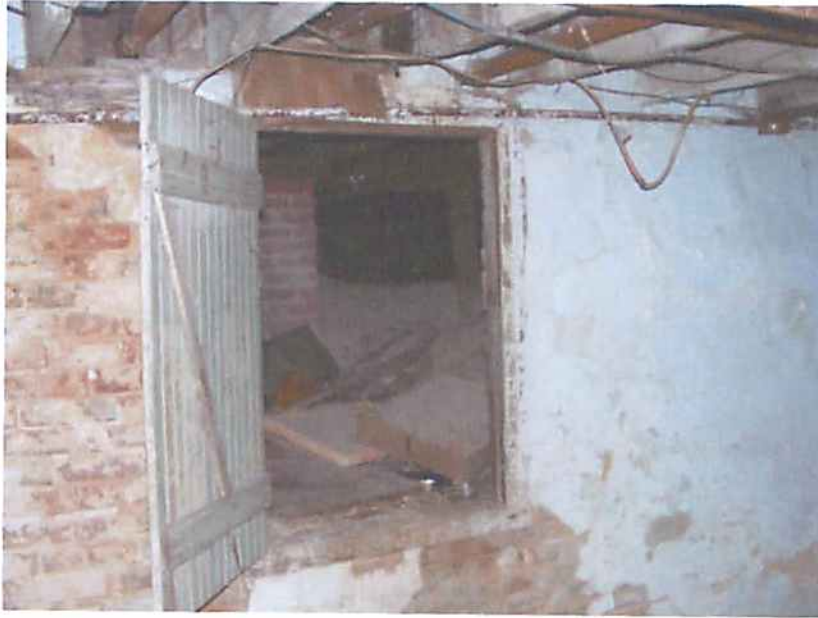
**Photo L1 Structure #2228 - Access Opening to Crawl Space**

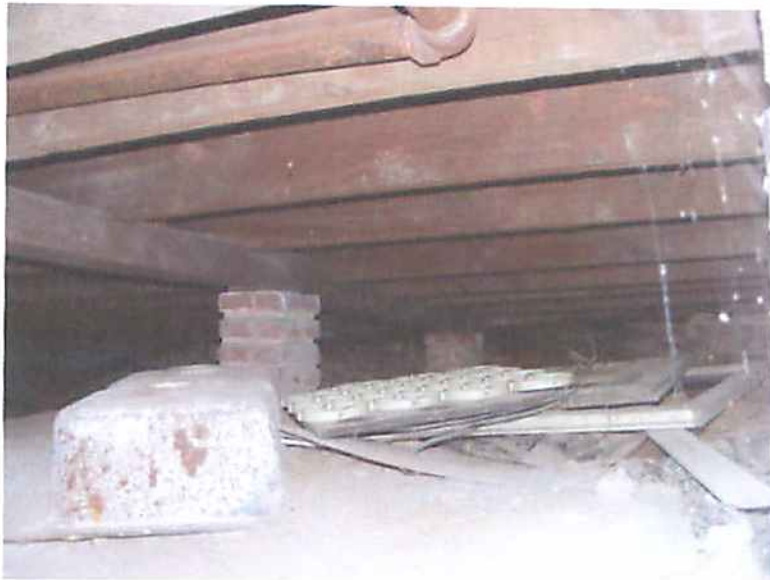
**Photo L2 Structure #2228 - First Floor Framing Above Crawl Space-  
Shows Deflected Beams and Deteriorated Brick Piers and Brick Walls  
Beyond**

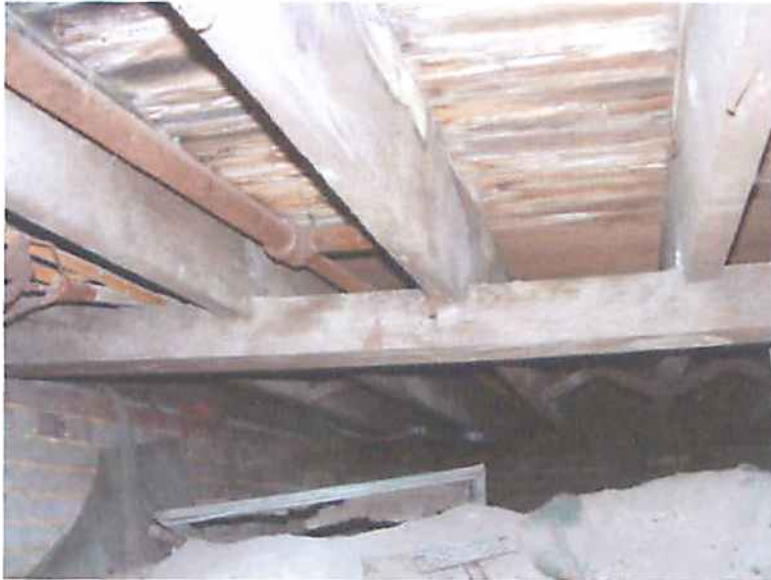
**Photo L3 Structure #2228 - Shows Water Damage to First Floor Planking Above Crawl Space**

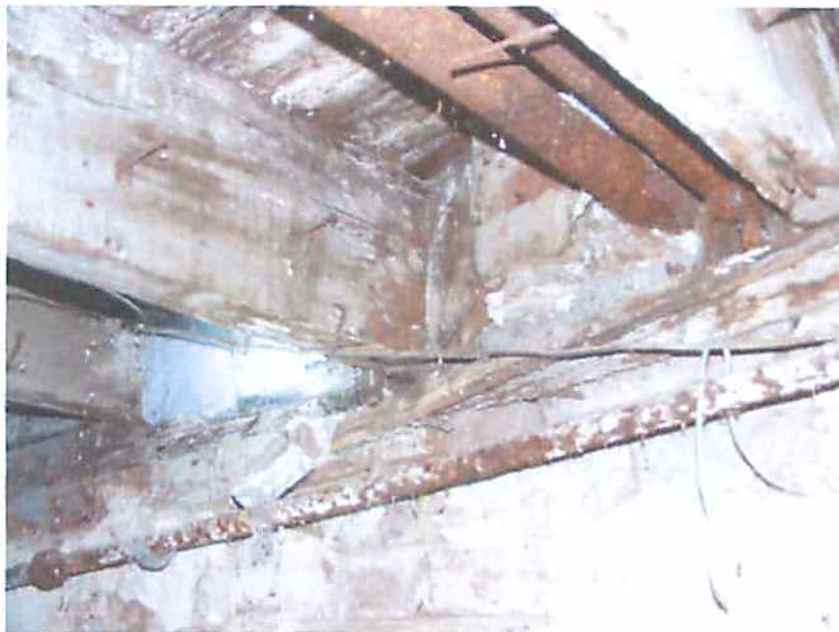
**Photo L4 Structure #2228 - Shows Typical Deteriorate Wood Plates, Joists, Planking and Studs at Exterior Walls in Basement Area**

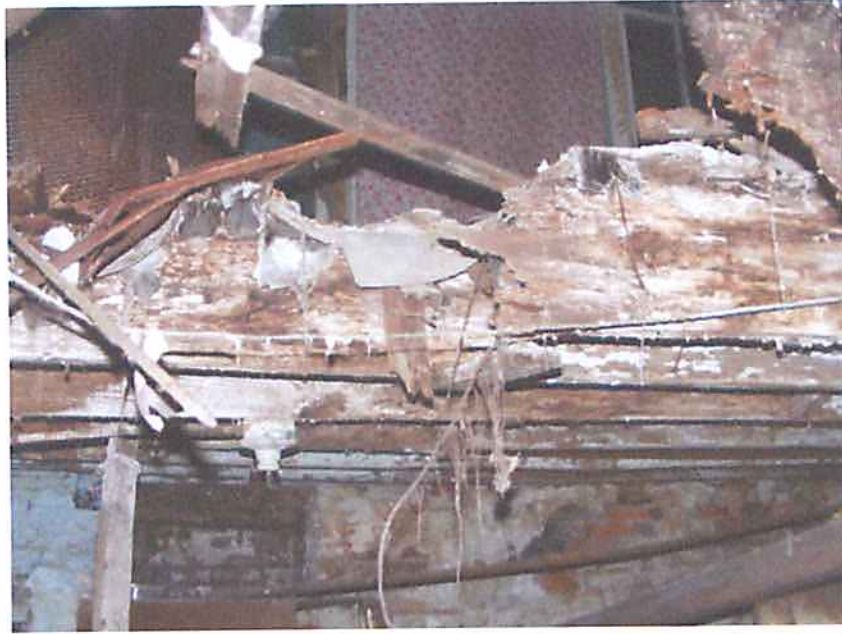
**Photo L5 Structure #2228 - Shows Collapsed First Floor Framing**

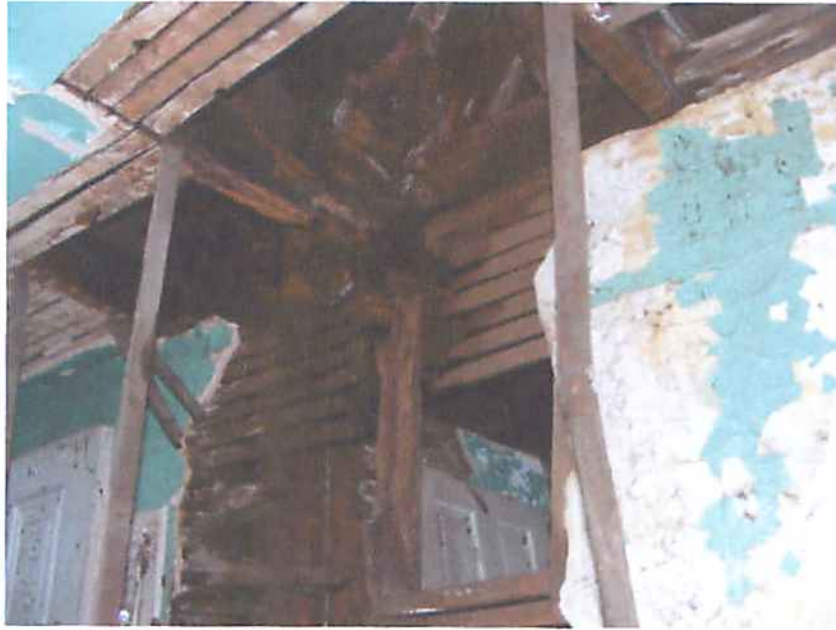
**Photo L11 Structure #2228 - Shows Collapse and Deteriorated Roof Framing**

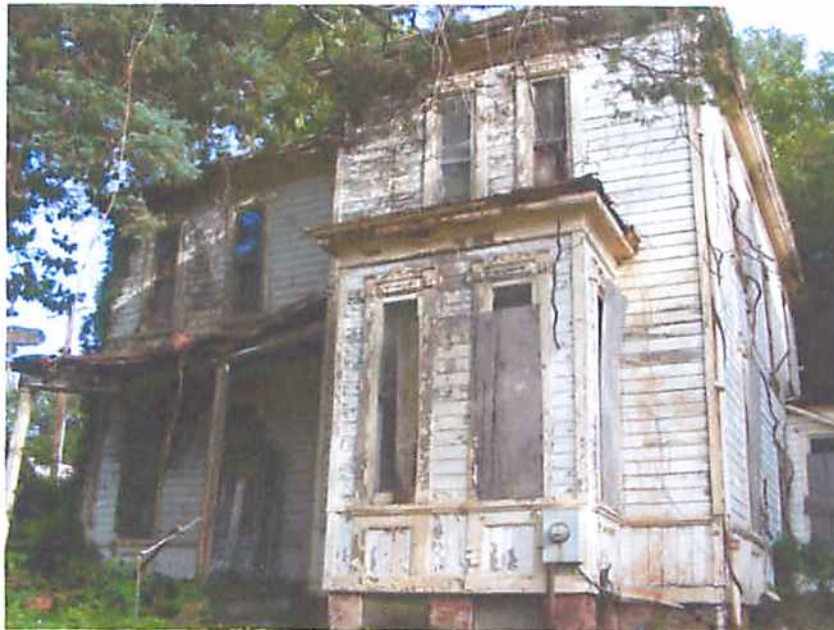
**Photo L12 Structure #2228 - Front of Building #2228**

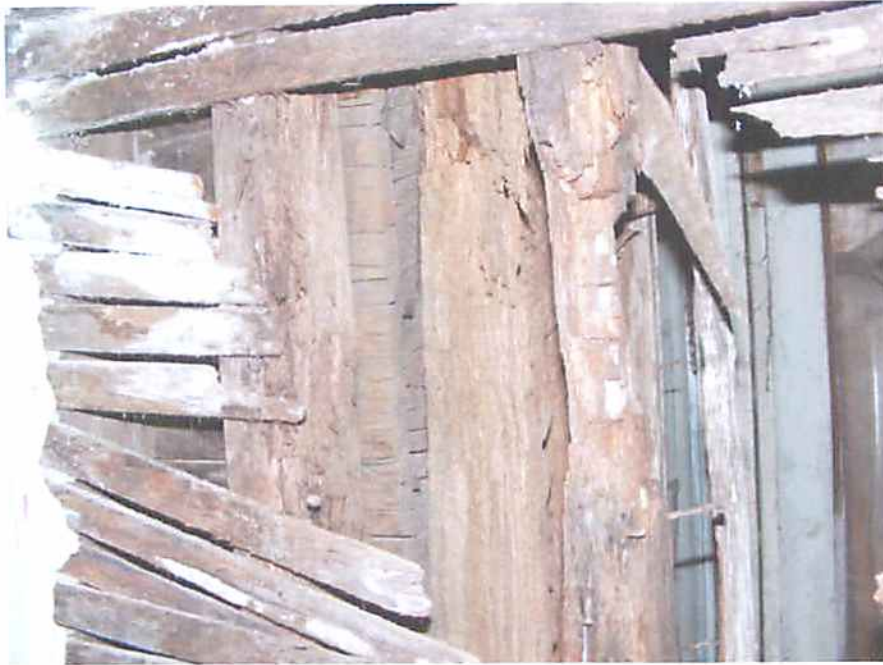
**Photo L15 Structure #2228 - Deterioration of Interior Bearing Stud Wall  
Between First and Second Floor**

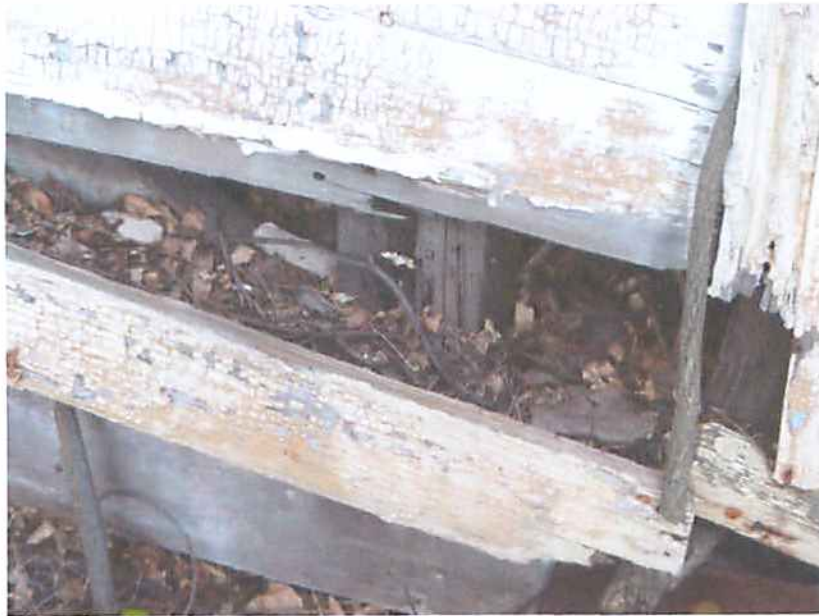
**Photo L-16 Structure #2228 - Deteriorated Exterior Studs and Wood  
Shingles, Termite and Water Damage**
